# Papdale Conservation Statement

Orkney Islands Council  
Development & Marine  
Planning

November 2013

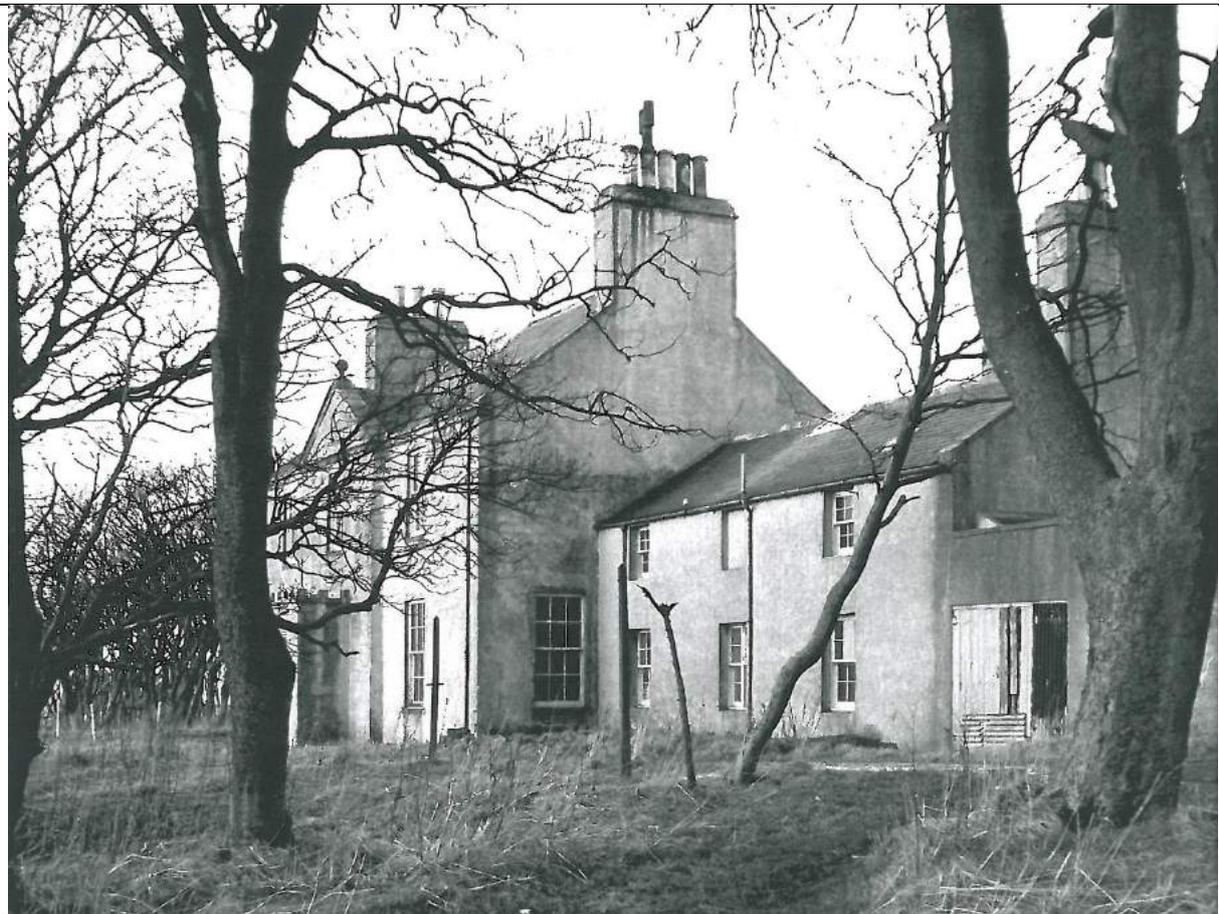
*Figure 11:  
Papdale House in the late 1960s, prior to its restoration. Note the servants' wing and castellated south porch.  
Image courtesy of Orkney Library and Archive, ref. D31/29/3.*

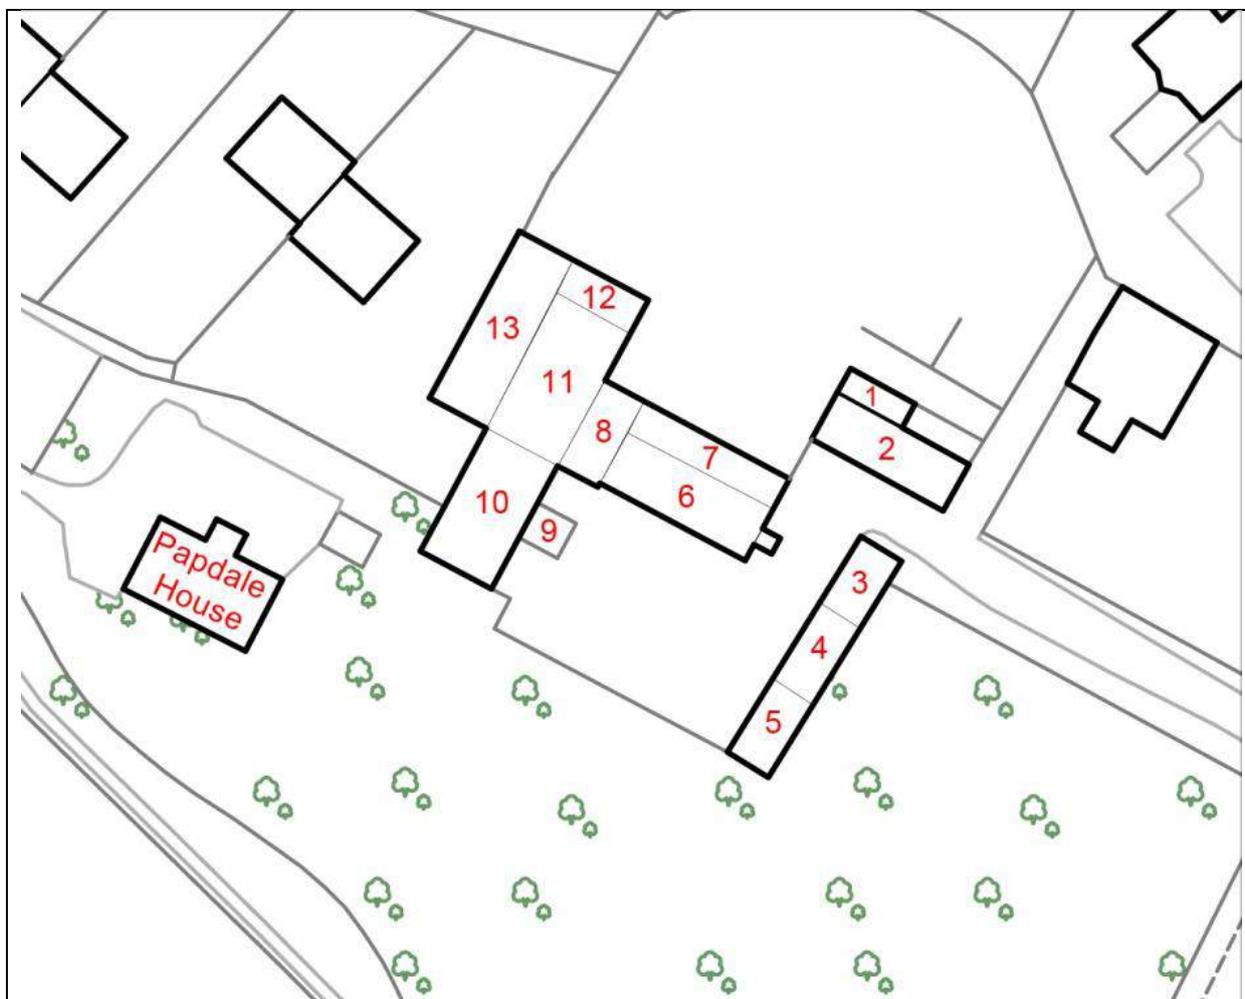
*Figure 15:*

*Map of Papdale House and Farm with buildings labelled.*

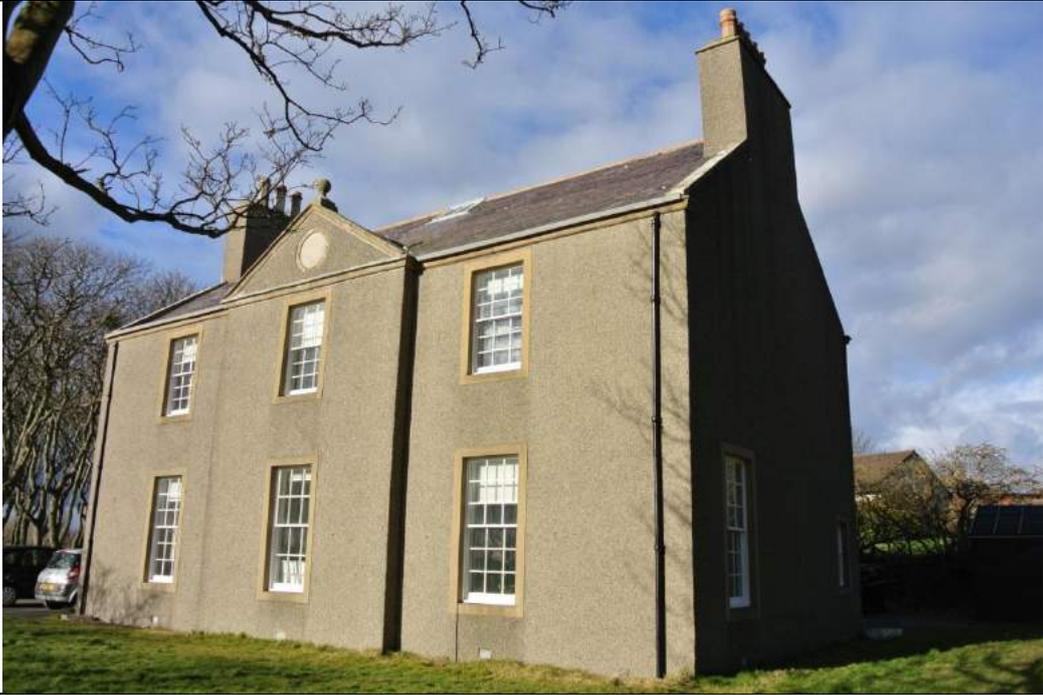
General condition:	Fair – some maintenance issues (damaged rainwater goods, dampness) need to be addressed. Reinforcement bars in concrete around openings in porch are rusting and visible. Evidence of historic settlement, which appears to have stopped.

*Figure 16:  
South façade of Papdale House (looking N)  
Photo: Tom Hunter*

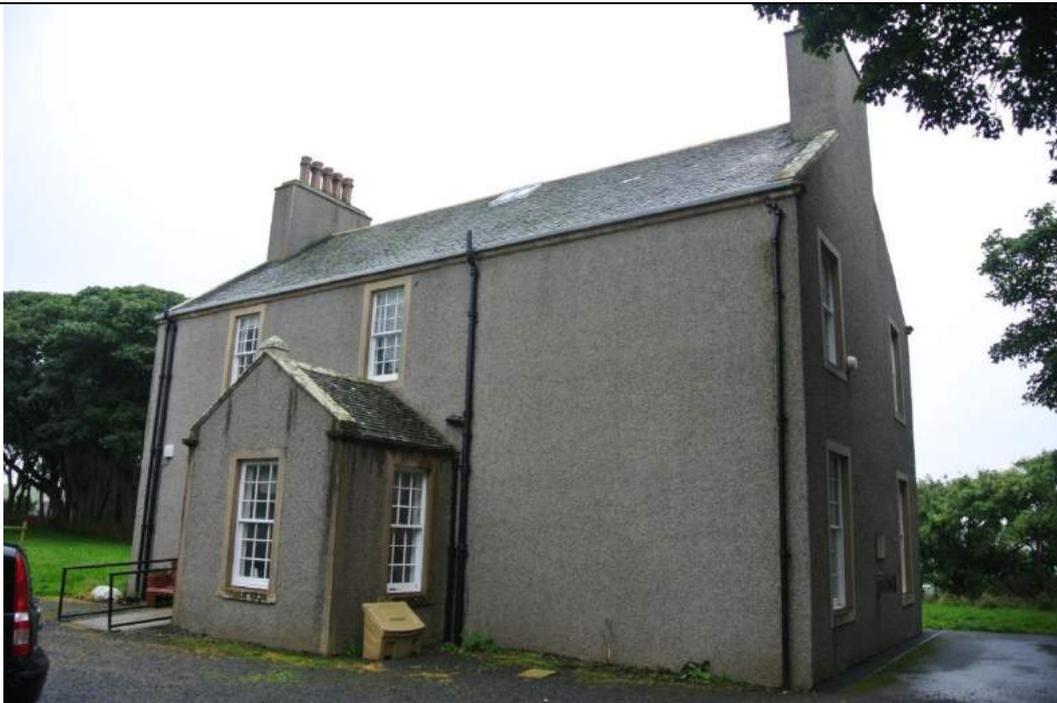
*Figure 17:  
North façade of Papdale House, with entrance porch (looking S)  
Photo: Tom Hunter*

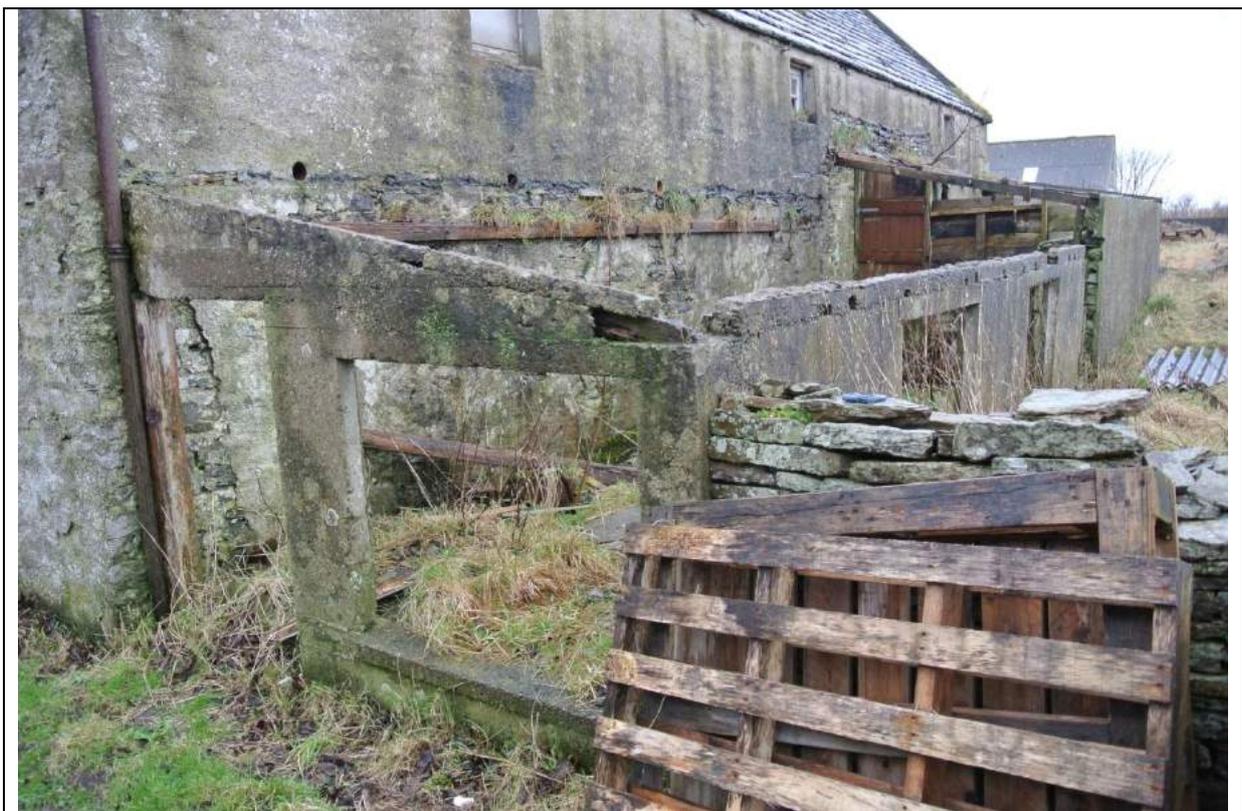
<p>Reproduced from the Ordnance Survey mapping with the permission of the Controller of her Majesty's Stationery Office © Crown Copyright. Unauthorised reproduction infringes Crown Copyright and may lead to prosecution or civil proceedings. Orkney Islands Council 100021621. For reference purposes only. 2013</p>	General description:	Monopitch single-storey lean-to outbuilding on north wall of Building 2.
	Age:	Post 1980
	Roof:	Absent, rafters remain.
	Walls:	Concrete block
	Windows and Doors:	Absent
	Rainwater goods:	Absent
	Interior:	No noteworthy features
	General condition:	Ruinous

Figure 19:  
 Building 1 seen from boundary of Papdale Farmhouse (looking W)  
 Photo: Tom Hunter

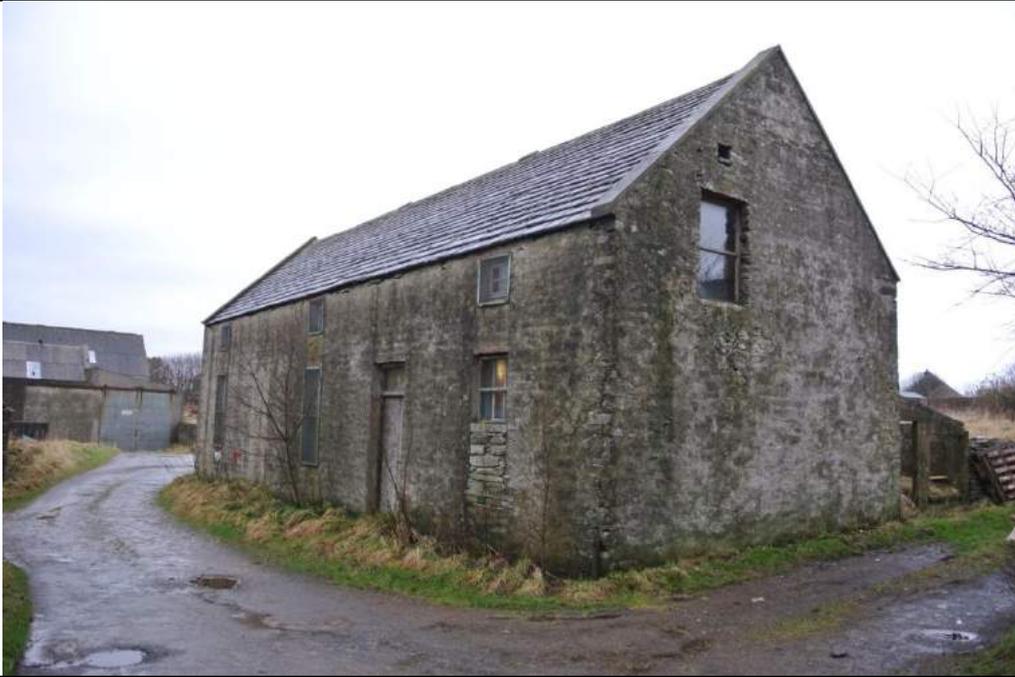
<p>Reproduced from the Ordnance Survey mapping with the permission of the Controller of her Majesty's Stationery Office © Crown Copyright. Unauthorised reproduction infringes Crown Copyright and may lead to prosecution or civil proceedings. Orkney Islands Council 100021621. For reference purposes only. 2013</p>	General description:	Two-storey traditional farm building, with modern external concrete staircase providing access via upper floor. Currently used as a weight-lifting gym. Timber work (inc roof structure and first floor) appears to have been replaced late C19th/early C20th. Marked as Farm Offices on Dundas plan.
	Age:	Earlier than 1832, believed part of Malcolm & Samuel Laing's Improved farm
	Roof:	Double pitched, with traditional sandstone tiles. Fireclay ridge & cast concrete skews.
	Walls:	Stone, render in poor condition.
	Windows and Doors:	Ground floor door blocked. Upper floor door modern. Windows mostly either blocked up or fitted with steel mesh grilles.

Rainwater goods:	Cast iron.
	Interior:	Currently in use as a weight-training gym. Timber lintels exposed internally, apparently original. Some pieces of ironwork still survive attached to later timber work.
	General condition:	Wind- and water-tight, main building appears structurally sound. Concrete access stair collapsing.

*Figure 20:  
Building 2 viewed from entrance to farm (looking N)  
Photo: Tom Hunter*

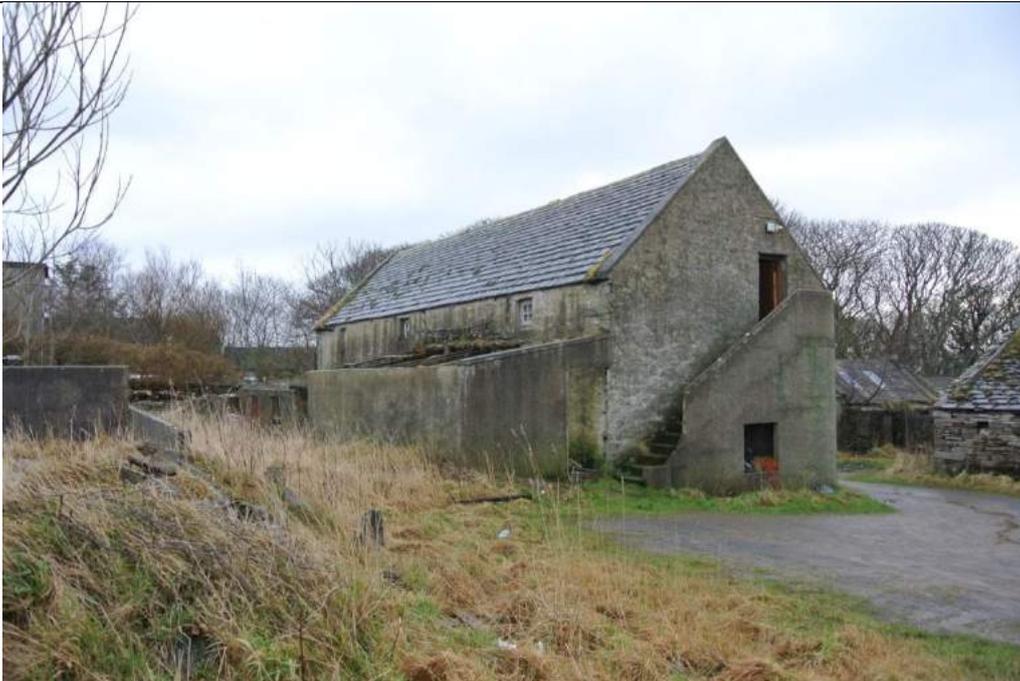
*Figure 21:  
Building 2 viewed from waste ground to N (looking S)  
Photo: Tom Hunter*

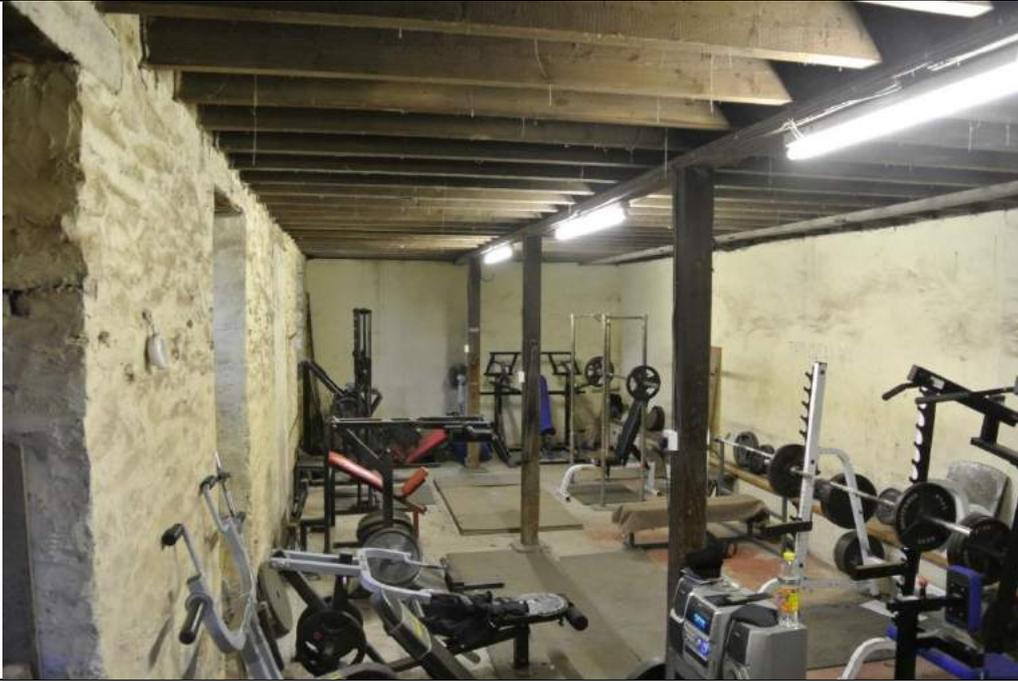
*Figure 22:  
Ground floor interior of Building 2  
Photo: Tom Hunter*

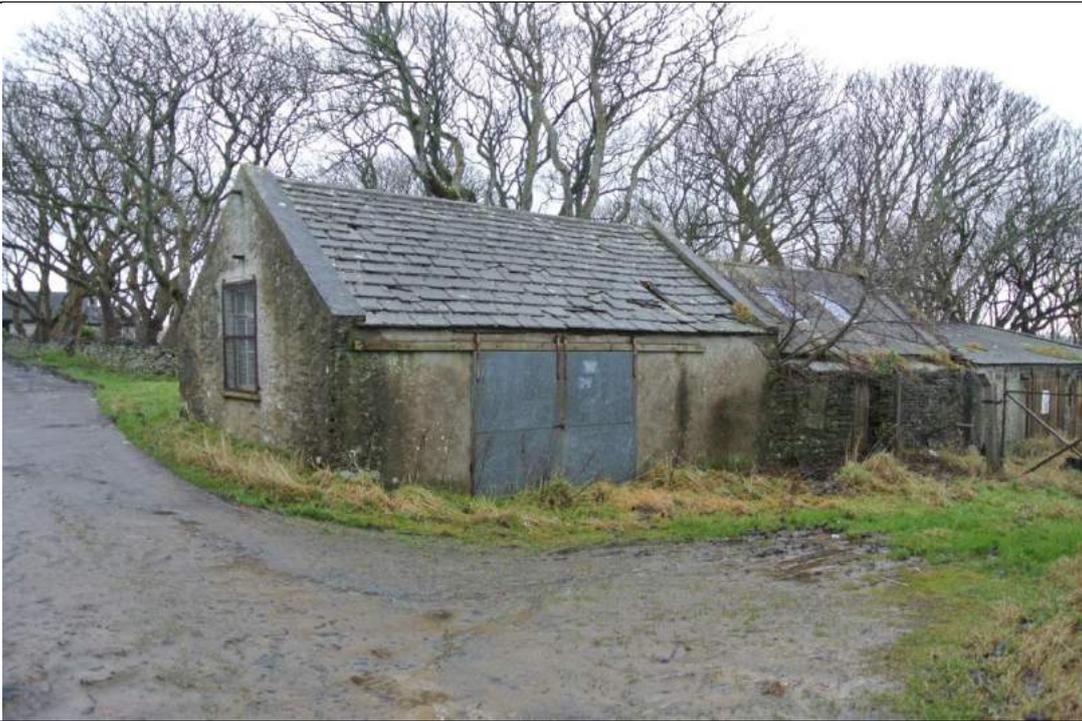
<b>General description:</b>	Single-storey farm building, part of a group of similar (with buildings 4 & 5) along east side of the courtyard.
	<b>Age:</b>	Built between mid-C19th and 1950.
	<b>Roof:</b>	Double pitched, with traditional sandstone tiles. Cast concrete skews.
	<b>Walls:</b>	Stone, thin smooth cement render.
<i>Reproduced from the Ordnance Survey mapping with the permission of the Controller of her Majesty's Stationery Office © Crown Copyright. Unauthorised reproduction infringes Crown Copyright and may lead to prosecution or civil proceedings. Orkney Islands Council 100021621. For reference purposes only. 2013</i>	<b>Windows and Doors:</b>	Sliding agricultural door, locked. Window in gable, covered with steel mesh grille.
	<b>Rainwater goods:</b>	Absent.
	<b>Interior:</b>	Not seen.
	<b>General condition:</b>	Derelict. Some holes in roof, cracks in walls. Structural integrity of west wall affected by tree growth in building 4.

*Figure 23:  
Building 3 from the north side of Building 7 (looking S)  
Photo: Tom Hunter*

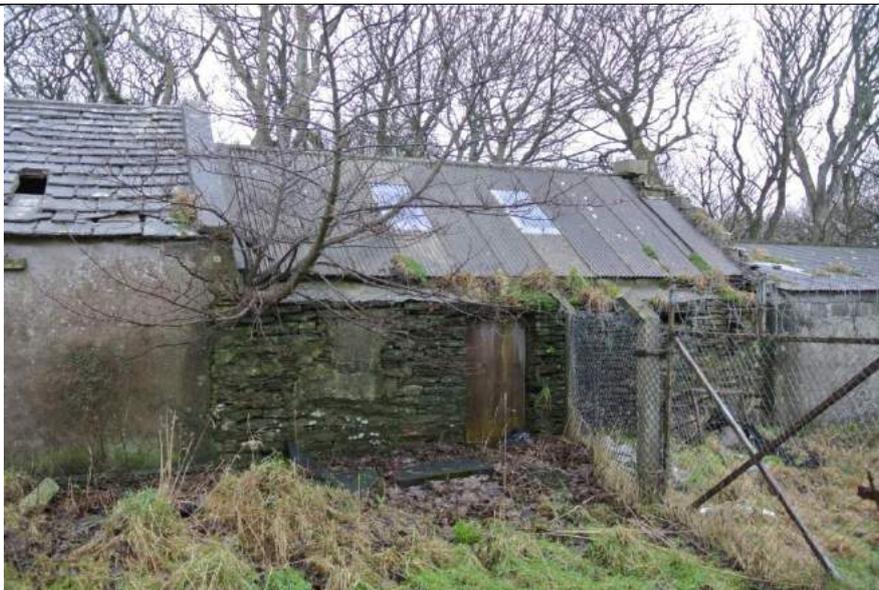
<p>Reproduced from the Ordnance Survey mapping with the permission of the Controller of her Majesty's Stationery Office © Crown Copyright. Unauthorised reproduction infringes Crown Copyright and may lead to prosecution or civil proceedings. Orkney Islands Council 100021621. For reference purposes only. 2013</p>	General description:	Single-storey farm building, probably a former dwelling, part of a group (with 3 & 5) along east side of courtyard. Historic photograph appears to show building inhabited by a family ( <i>Figure 14</i> , p. 17).
	Age:	Earlier than 1832, believed part of Malcolm & Samuel Laing's Improved farm.
	Roof:	Double pitched, corrugated metal sheeting. Crowstepped gable on south end.
	Walls:	Exposed stonework, originally harled.
	Windows and Doors:	Blocked/boarded up.
	Rainwater goods:	Absent
	Interior:	Not seen.
	General condition:	Ruinous, tree growing from west wall.

*Figure 25:*  
*Building 4 seen from E side of Building 6 (looking SE)*  
*Photo: Tom Hunter*

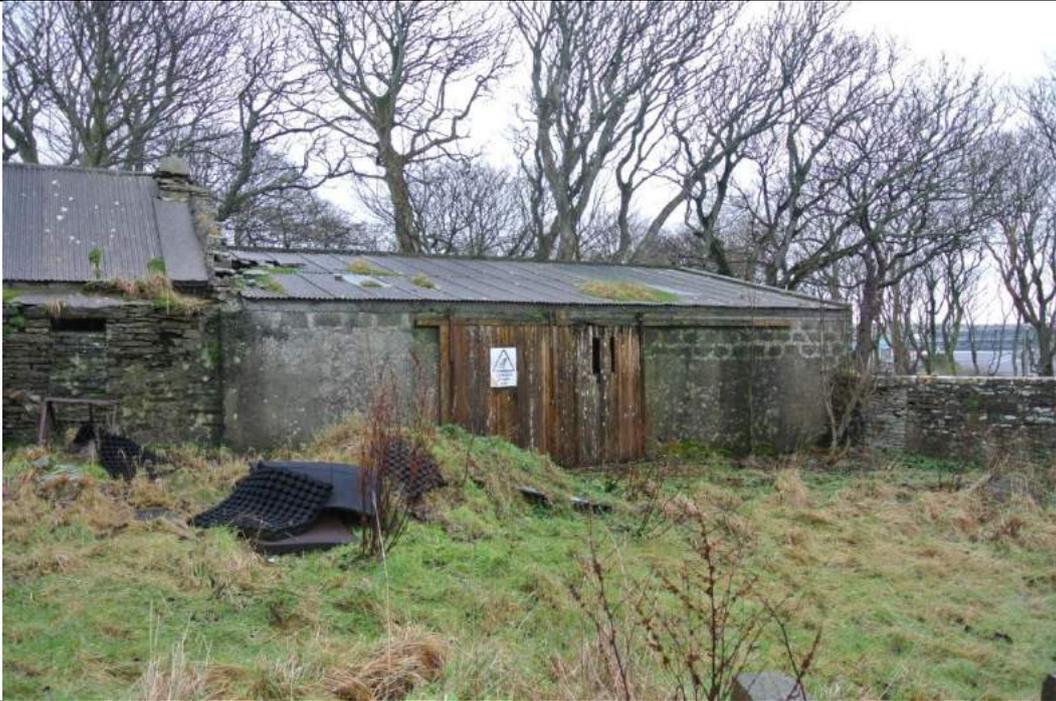
<p>Reproduced from the Ordnance Survey mapping with the permission of the Controller of her Majesty's Stationery Office © Crown Copyright. Unauthorised reproduction infringes Crown Copyright and may lead to prosecution or civil proceedings. Orkney Islands Council 100021621. For reference purposes only. 2013</p>	General description:	Single storey farm building, part of a group (with 3 & 4) along east side of courtyard.
	Age:	Twentieth century, probably built at some point before 1963.
	Roof:	Monopitch, corrugated sheet metal. Some holes caused by collapsing masonry from Building 4.
	Walls:	Concrete block, incorporating some reclaimed stonework. Concrete block quoins indicate modern construction.
	Windows and Doors:	Modern sliding agricultural door in poor condition.
	Rainwater goods:	Absent
	Interior:	Some debris, no notable features.
	General condition:	Derelict, wall structure appears intact.

*Figure 26:  
Building 5 from courtyard (looking SE)  
Photo: Tom Hunter*

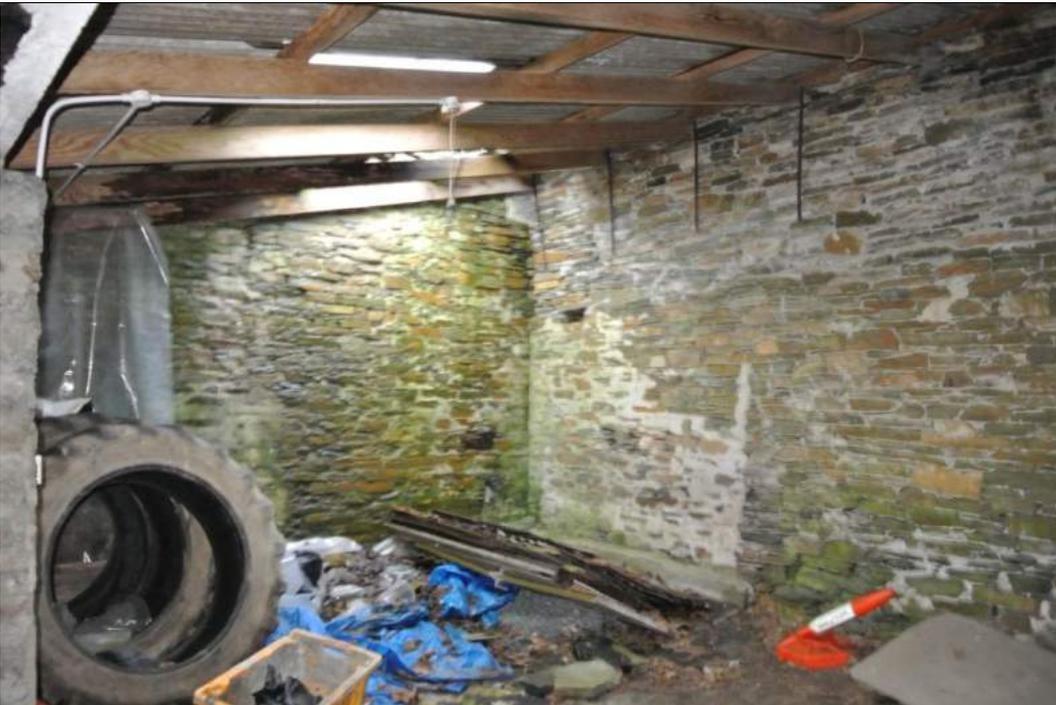
*Figure 27:  
Interior of Building 5  
Photo: Tom Hunter*

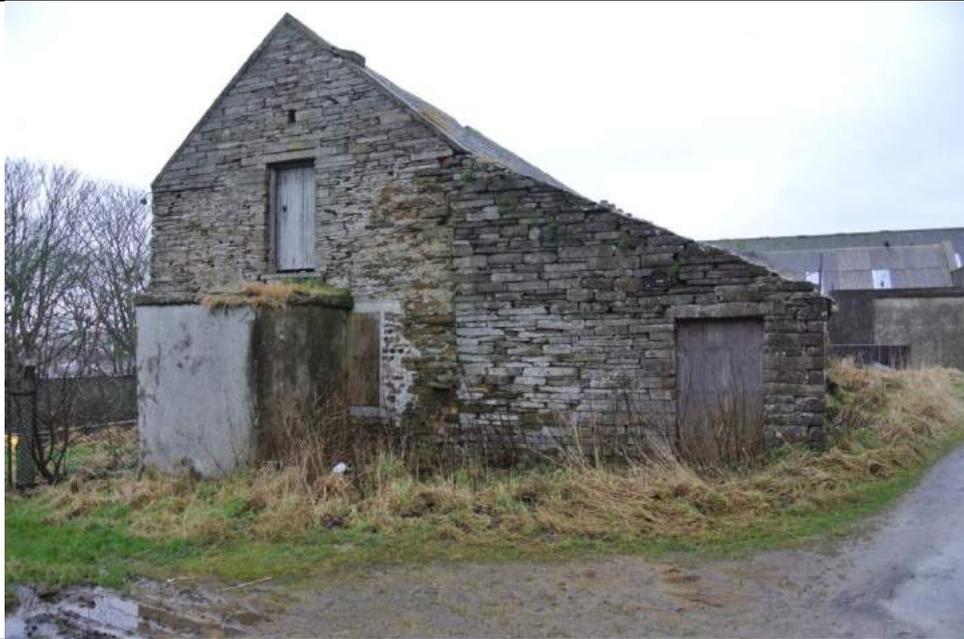
General condition:	Appears wind- and water-tight, although structural integrity of walls/roof/floor uncertain.

*Figure 28:  
Building 6 (left-hand structure) with Building 7 (lean-to on right hand side) adjoining.  
Seen from entrance to farm (looking W).  
Photo: Tom Hunter*

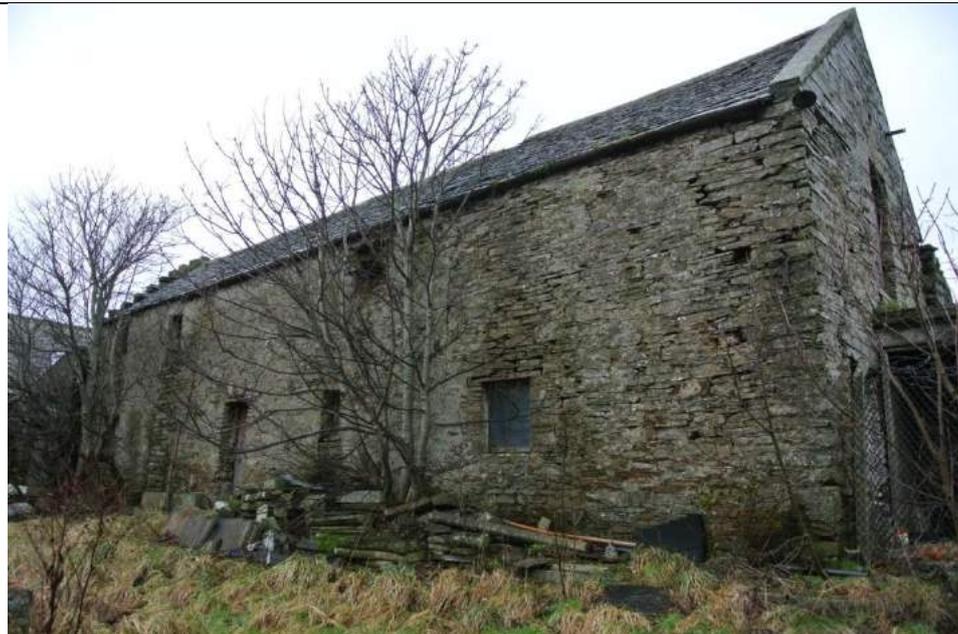
<p><i>Reproduced from the Ordnance Survey mapping with the permission of the Controller of her Majesty's Stationery Office © Crown Copyright. Unauthorised reproduction infringes Crown Copyright and may lead to prosecution or civil proceedings. Orkney Islands Council 100021621. For reference purposes only. 2013</i></p>	General description:	Two storey traditionally built byre, with doocot on upper floor.
	Age:	Earlier than 1832, believed part of Malcolm & Samuel Laing's Improved farm.
	Roof:	Double pitched with traditional sandstone tiles. Stone ridges. Crowstepped west gable; east gable has cast concrete skewes.
	Walls:	Exposed stone.
	Windows and Doors:	Window openings boarded up, timber lintels remain. Timber doors, appear to be modern replacements. Currently accessed via Building 8.
	Rainwater goods:	Some cast-iron rhones remaining.
	Interior:	Ground floor: Floor appears to be sandstone cobbles covered with concrete, with an integral drainage channel. Timber stall partitions survive with some iron fittings. Timber staircase. Upper floor: Timber floorboards. Doocot formed from brickwork set into walls.

*Figure 29:  
Building 6 from courtyard (looking N)  
Photo: Tom Hunter*

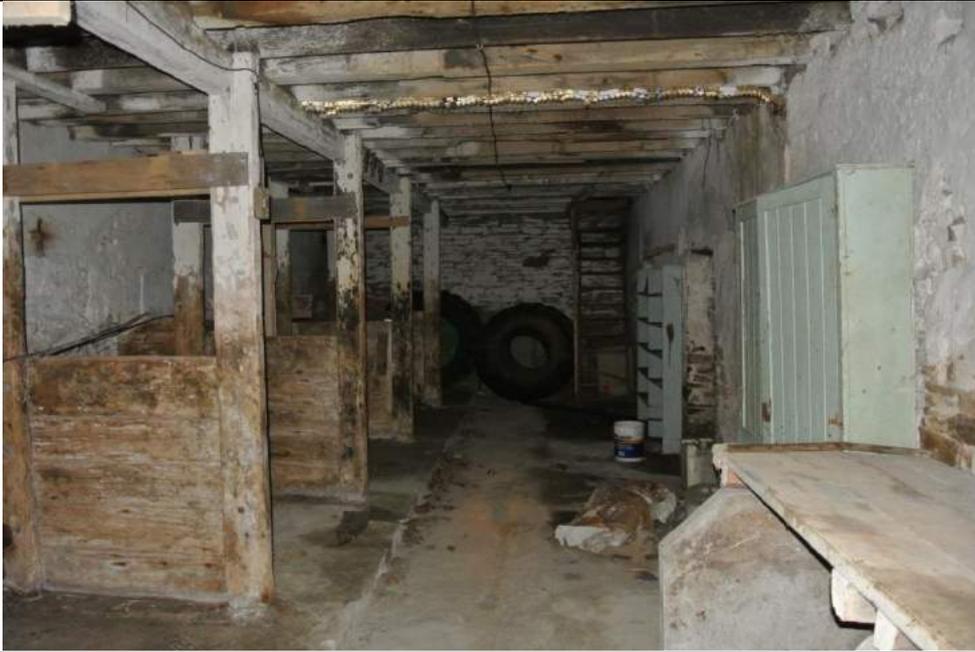
*Figure 30:  
Ground floor interior of Building 6, with cattle stalls on left hand side and ladder to  
upper floor at rear  
Photo: Tom Hunter*

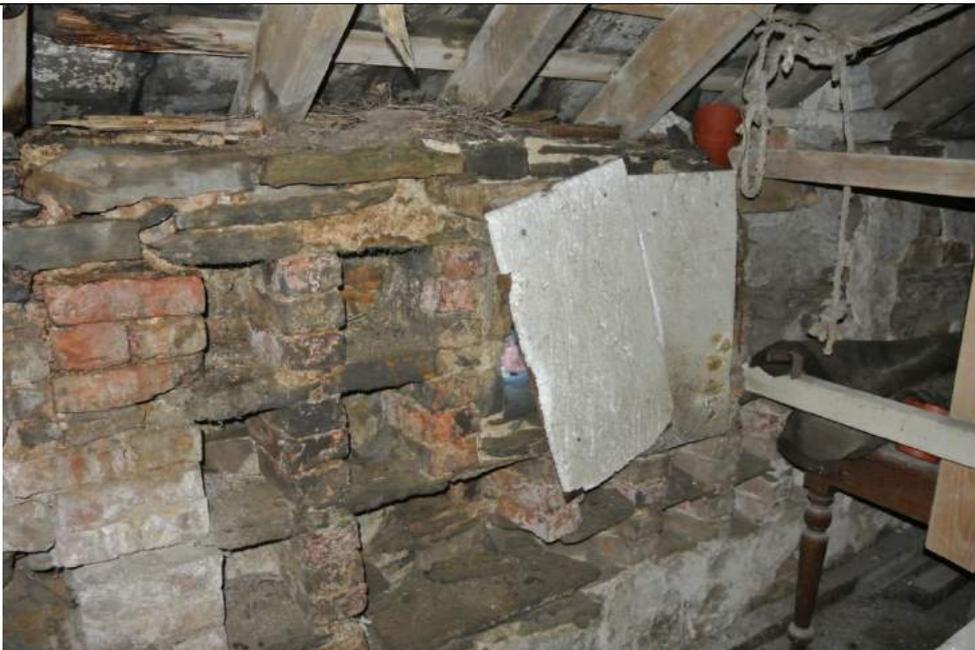
*Figure 31:  
Doo cot built into walls on upper floor of Building 6  
Photo: Tom Hunter*

The farm buildings of traditional construction (2, 4, 6 & 7) generally display a high level of authenticity. Many original features, such as the doocot in Building 6, survive intact. These buildings have been little altered since their construction, and where significant works have since taken place (such as re-roofing in Building 2) these are historic, and can be seen as sympathetic repairs rather than restoration or alteration.

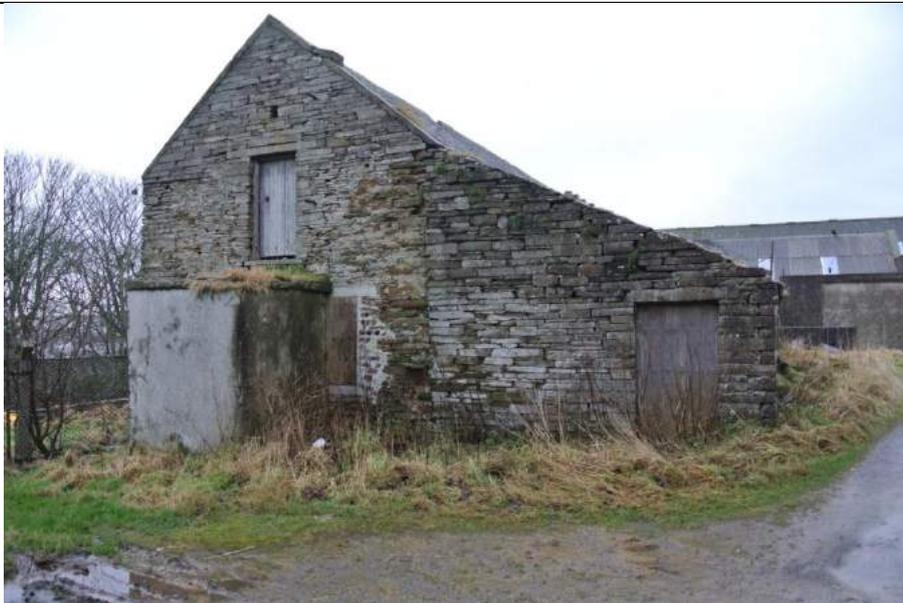
<p><i>Reproduced from the Ordnance Survey mapping with the permission of the Controller of her Majesty's Stationery Office © Crown Copyright. Unauthorised reproduction infringes Crown Copyright and may lead to prosecution or civil proceedings. Orkney Islands Council 100021621. For reference purposes only. 2013</i></p>	General description:	Large two-storey traditionally-built lean-to on north side of Building 6, extending along its entire length.
	Age:	Built between 1880 and 1950.
	Roof:	Monopitch with traditional sandstone tiles. Cast skews in poor condition on both gables. Some leaks have caused rafters to rot and collapse locally.
	Walls:	Stone, larger blocks than Building 6.
	Windows and Doors:	Boarded up.
	Rainwater goods:	Absent.
	Interior:	Flagstone floor with drainage channel. Mid-twentieth century stall partitions.
	General condition:	Some damage to roof, walls appear structurally intact.

*Figure 32:  
Building 6 (left-hand structure) with Building 7 (lean-to on right hand side) adjoining. Seen from entrance to farm (looking W).  
Photo: Tom Hunter*

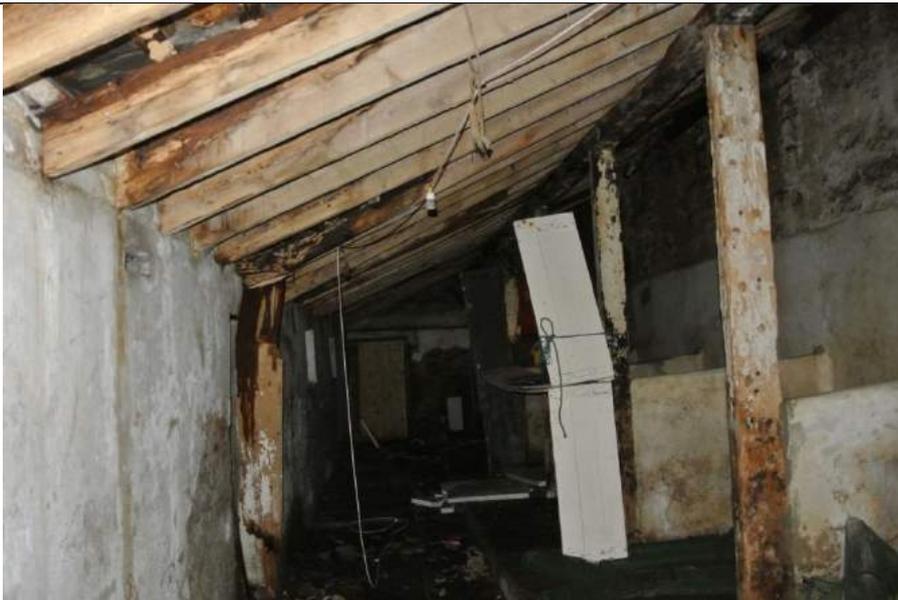
*Figure 34:  
Interior of Building 7. Note staining of timber by water penetration.  
Photo: Tom Hunter*

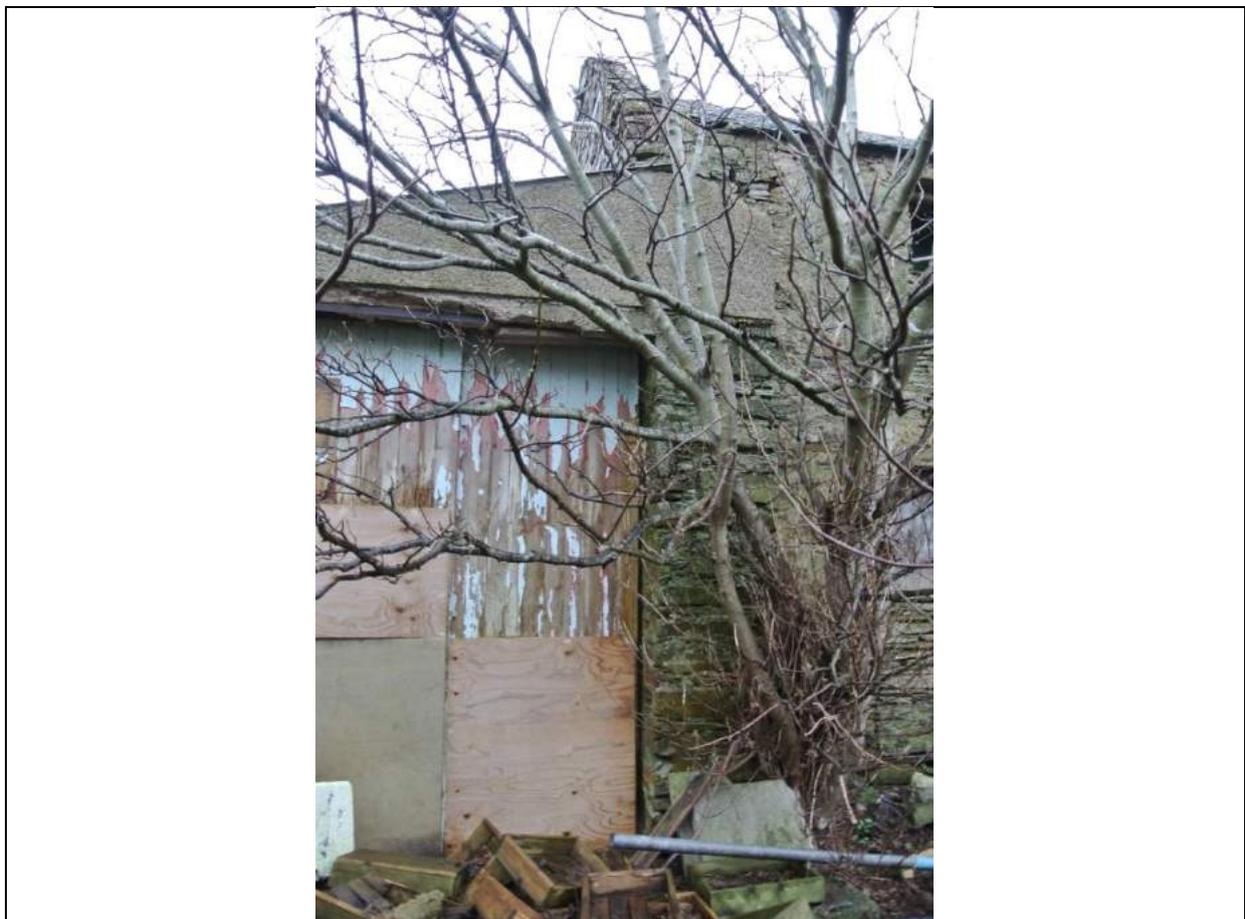
<p>Reproduced from the Ordnance Survey mapping with the permission of the Controller of her Majesty's Stationery Office © Crown Copyright. Unauthorised reproduction infringes Crown Copyright and may lead to prosecution or civil proceedings. Orkney Islands Council 100021621. For reference purposes only. 2013</p>	General description:	Small single-storey infill building between Buildings 6 & 7 (to the east) and Building 11 (to the west).
	Age:	Built between mid-C19th and 1950.
	Roof:	Monopitch, corrugated metal sheet.
	Walls:	Part reclaimed stone, part concrete block.
	Windows and Doors:	Vehicle access, boarded up.
	Rainwater goods:	Absent on gables, forms valley gutter with Building 11.
	Interior:	Debris, no noteworthy features.
	General condition:	Roof damaged, structure appears intact.

*Figure 35:  
Building 8 (garage door on left) seen from courtyard (looking N)  
Photo: Tom Hunter*

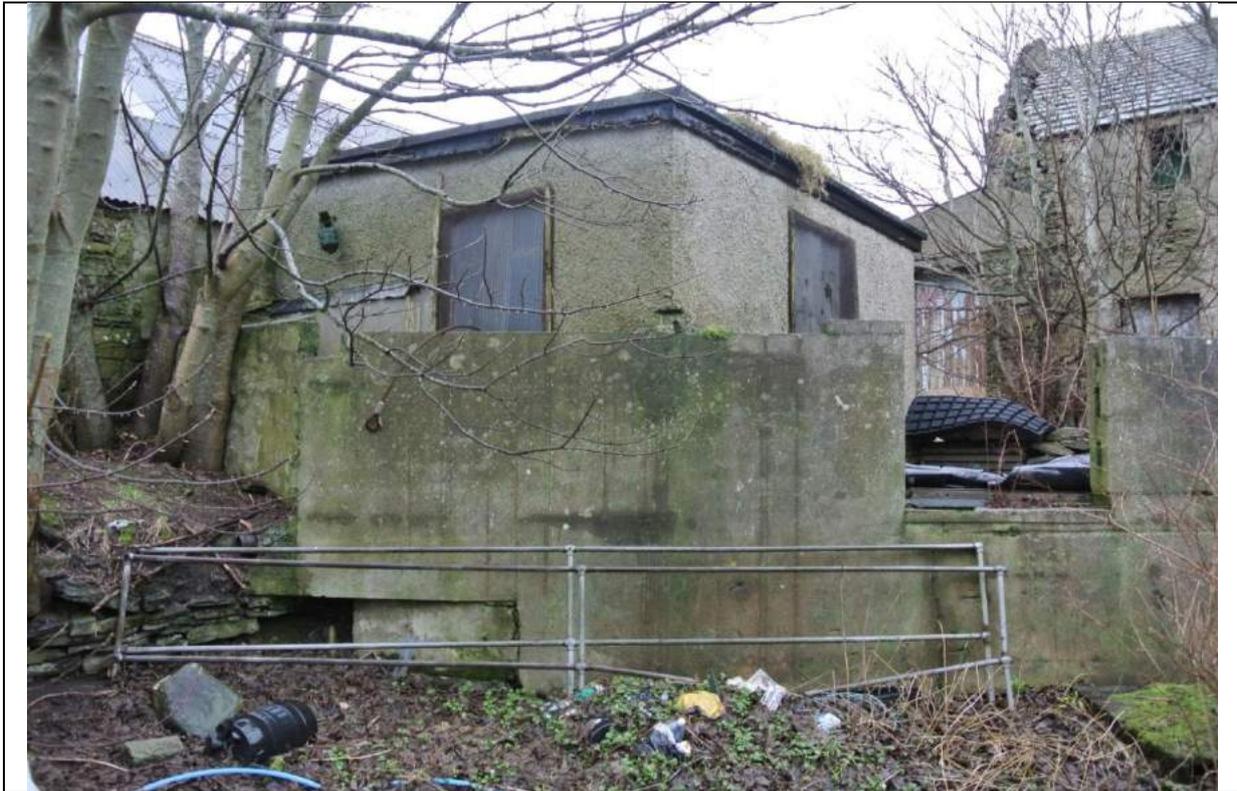
General description:	Small single-storey modern structure, rectangular in plan.
Age:	Built between 1964 and 1980.
Roof:	Flat roof, covered with roofing felt.
Walls:	Rendered, presumed concrete block.
Windows and Doors:	Sealed.
Rainwater goods:	Absent
Interior:	Not seen.
General condition:	Derelict, appears structurally sound.

Figure 37:  
 Building 9 seen from courtyard (looking N)  
 Photo: Tom Hunter

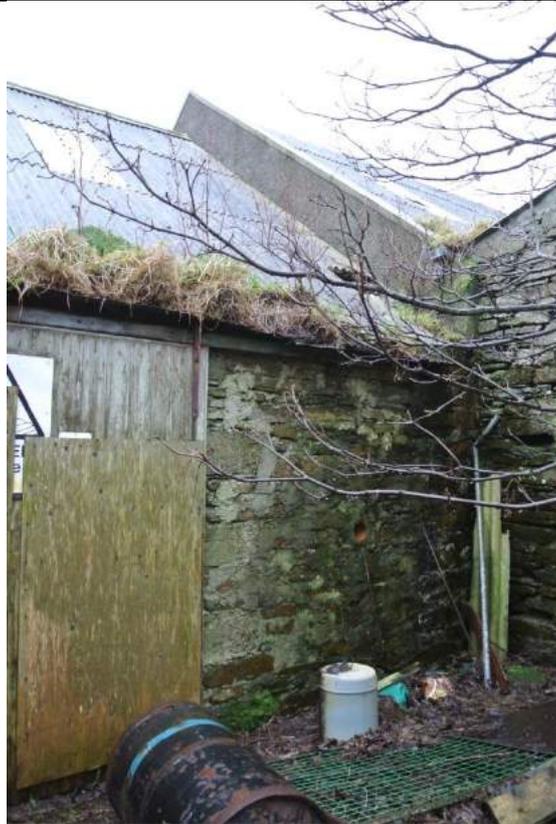
<p>Reproduced from the Ordnance Survey mapping with the permission of the Controller of her Majesty's Stationery Office © Crown Copyright. Unauthorised reproduction infringes Crown Copyright and may lead to prosecution or civil proceedings. Orkney Islands Council 100021621. For reference purposes only. 2013</p>	General description:	Large modern 2/3 storey barn.
	Age:	Built between mid-C19th and 1950.
	Roof:	Double pitched, with corrugated metal sheeting.
	Walls:	Reclaimed stone and internal cement render.
	Windows and Doors:	Boarded up, accessed via Building 11.
	Rainwater goods:	Absent.
	Interior:	Mid-twentieth century stall partitions.
	General condition:	Appears wind- and water-tight, structurally stable.

*Figure 38:  
Building 10 seen from courtyard (looking NW)  
Photo: Tom Hunter*

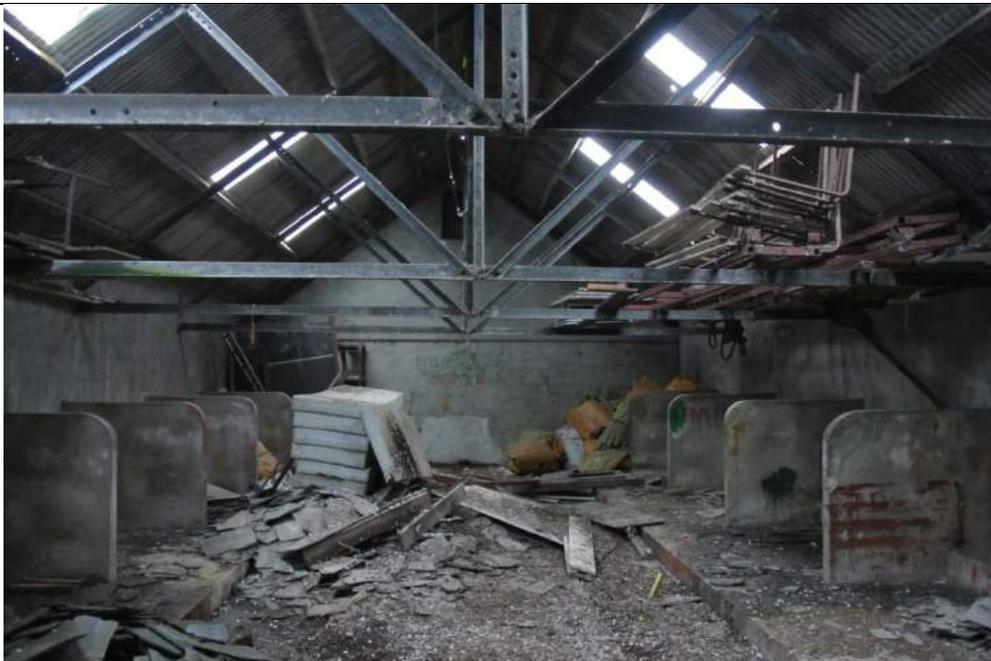
*Figure 39:  
Interior of Building 10, with concrete stalls.  
Photo: Tom Hunter*

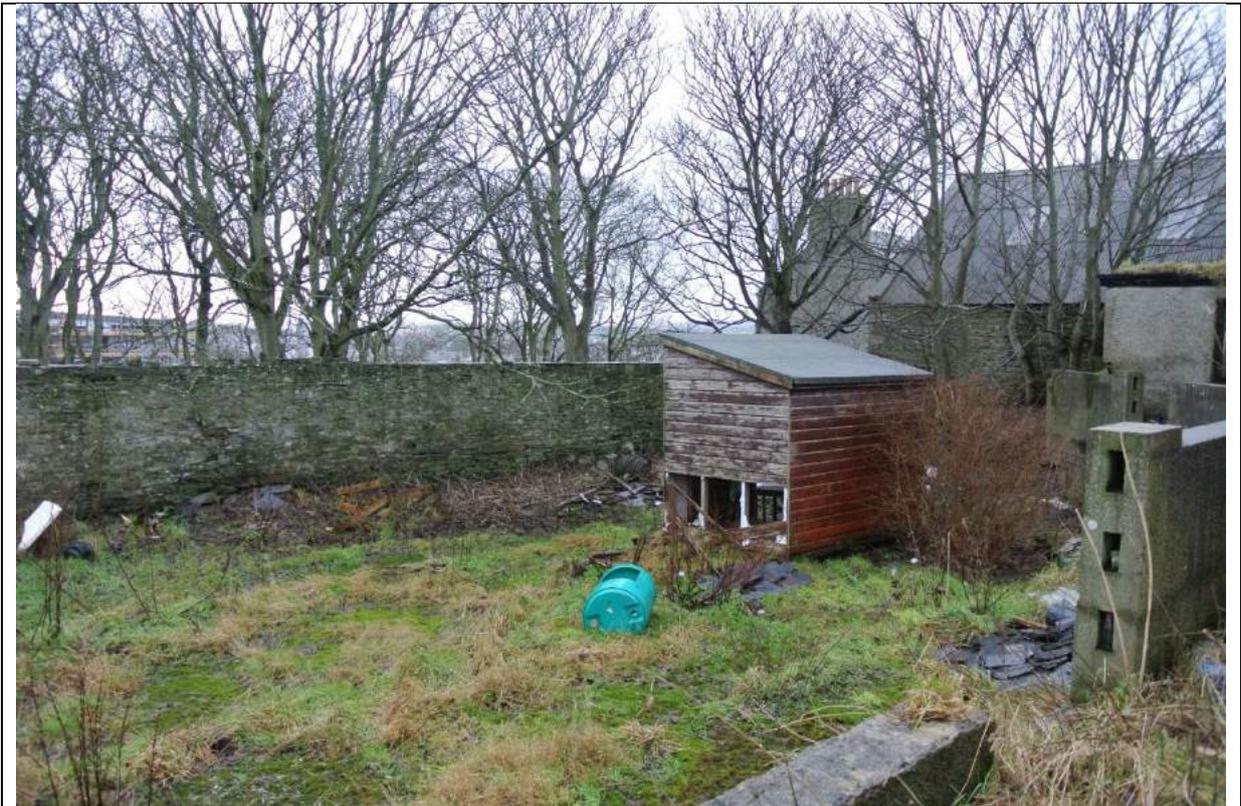
External areas around the steadings, including the main courtyard, are overgrown and covered by an accumulation of debris. Cobbles appear to be visible at certain points, but it has not been possible to assess the full extent and condition of any surviving historic surface materials. Surviving boundary walls are often damaged but generally appear structurally stable.

*Figure 44:  
View of courtyard from E corner (looking W)  
Photo: Tom Hunter*

The renovation of the courtyard should create a high-quality space which is in keeping with the historic character of the site. Where historic surface treatments, such as cobbles or setts, are found to remain, they should either be repaired appropriately and re-used, or should be preserved in situ and overlaid with sympathetically chosen modern materials, such as flagstones, setts, cobbles or an equivalent. Colours and forms should be well-chosen and sympathetic to the surrounding buildings, avoiding the use of colours which would not have been available historically. Continuous materials such as tarmac or concrete should not be used, because they would fundamentally alter the character of the space. Planting arrangements could contribute positively to the amenity of the space, but care should be taken to ensure that the scale is appropriate for the setting of the historic buildings.

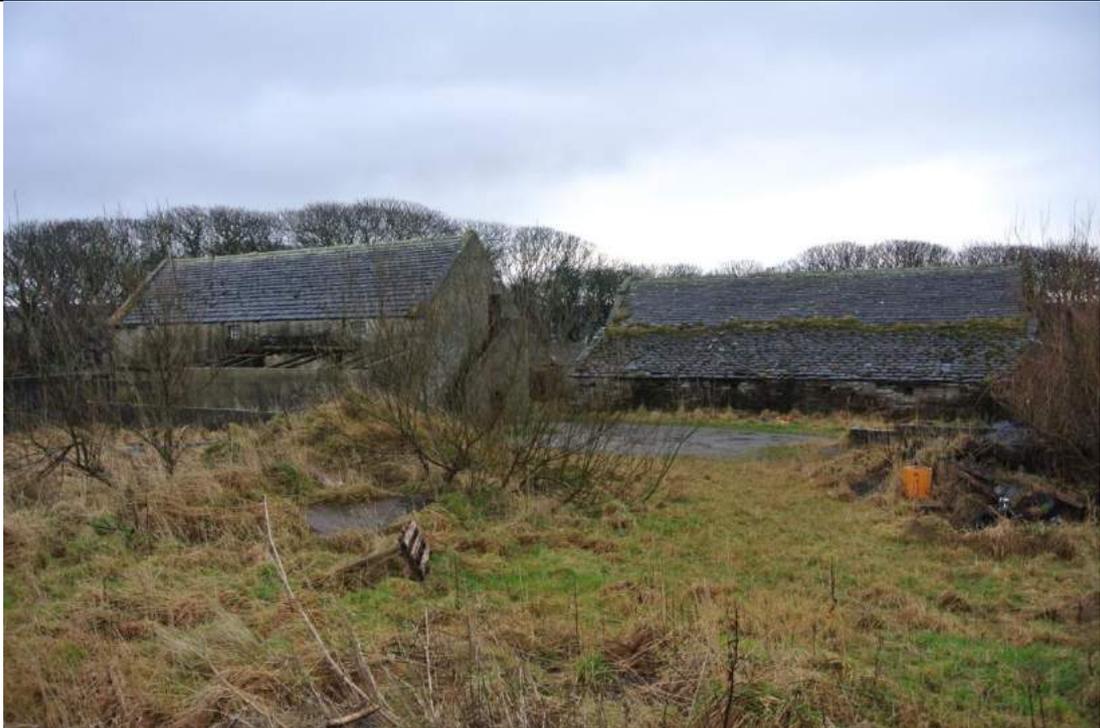
*Figure 45:  
View over waste ground to N of farm to Buildings 1, 2, 6 & 7 (looking S)  
Photo: Tom Hunter*

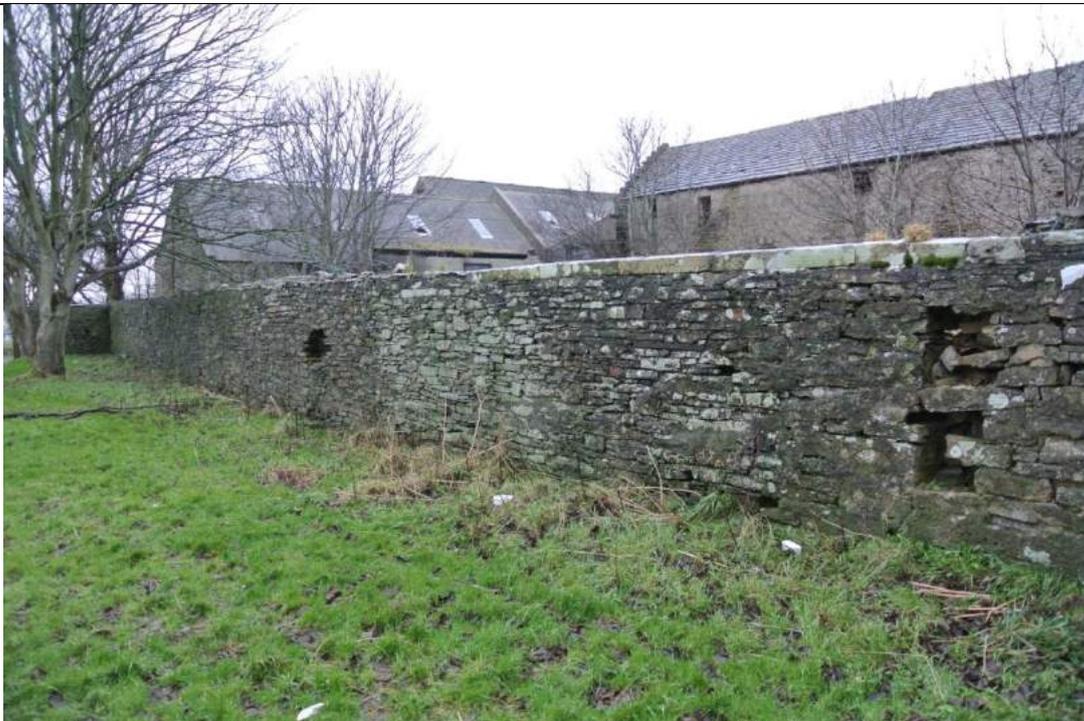
*Figure 46:  
Boundary wall which currently forms S edge of courtyard (looking NW)  
Photo: Tom Hunter*
