# Papdale Conservation Statement

Orkney Islands Council  
Development & Marine  
Planning

November 2013

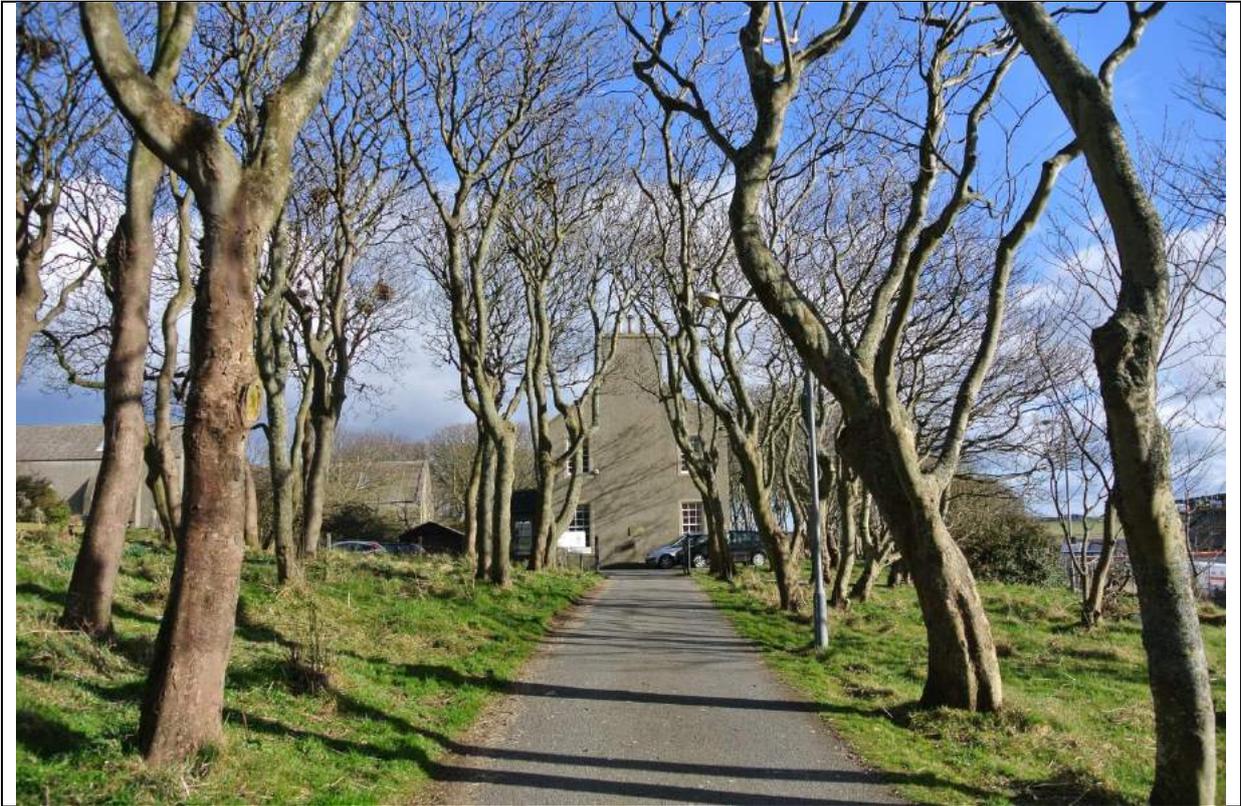
Much of the ornamental landscaping immediately around Papdale House survives, but has suffered from infrequent maintenance. The fencing and gateposts around the house have largely disappeared, and the addition of standard suburban streetlights does not contribute to the setting of the House.

*Figure 47:  
View down the avenue towards Papdale House (looking SE). Note streetlight on right hand side of path.  
Photo: Tom Hunter*

There is an opportunity to improve the legibility of the site by restoring the historic pathways, the definition of the earth bank and the gateposts which mark the garden boundary. The gateposts in particular are in a state of very poor repair, and should be conserved and restored as a priority.

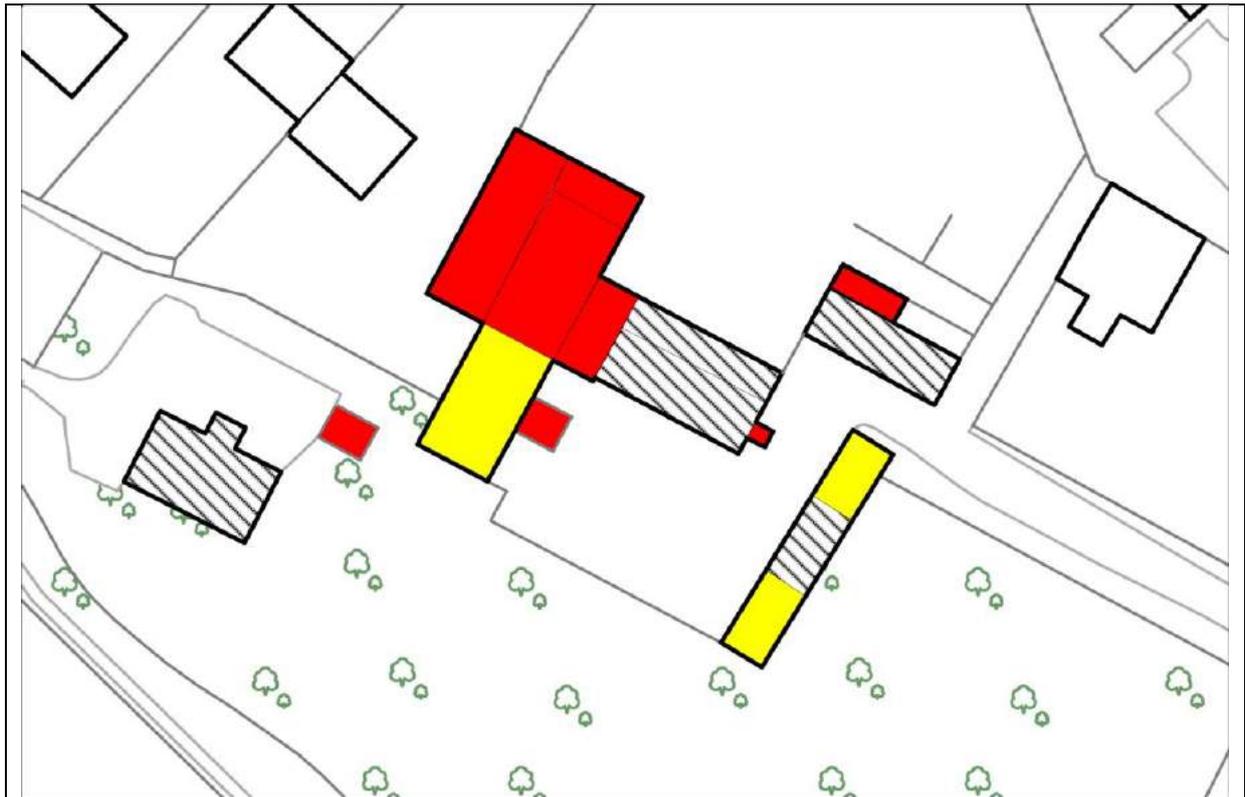
### Papdale by Category

- Modern agricultural buildings
- Modern agricultural buildings built using significant reclaimed stonework
- Traditionally constructed buildings

These are either believed to be original or sympathetic later additions, and are built using traditional methods and materials. They should be retained and conserved, and any unsympathetic additions removed. Their conditions vary from being in use to ruinous; a range of conservation approaches would therefore be appropriate, from in-situ preservation to controlled dismantling and reconstruction where required.

These are generally in poor repair and are detrimental to the character of the historic steadings. Their removal should therefore be supported. This would enhance the integrity of the complex, and gives scope for high-quality new development.

Modern agricultural buildings built using significant reclaimed stonework (3, 5, 10):

These are generally either in poor repair or are unsympathetic in design to the historic steadings. They should be considered eligible for removal, and any traditional stonework recovered should be salvaged and reused within the development as appropriate.

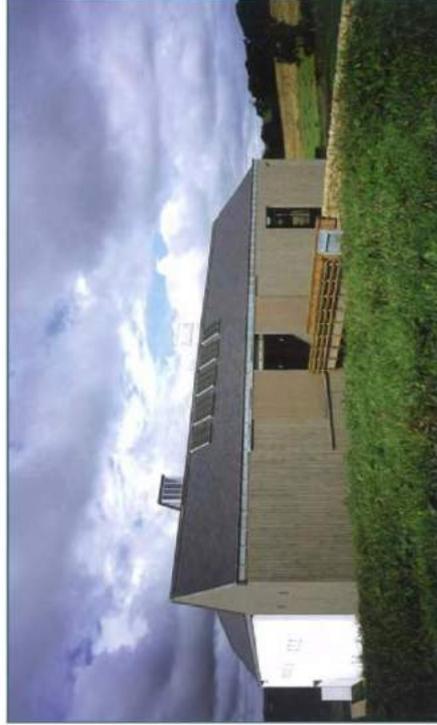
Contemporary public building responds to vernacular heritage without pastiche  
Museum of Rural Life, Kitchinshole

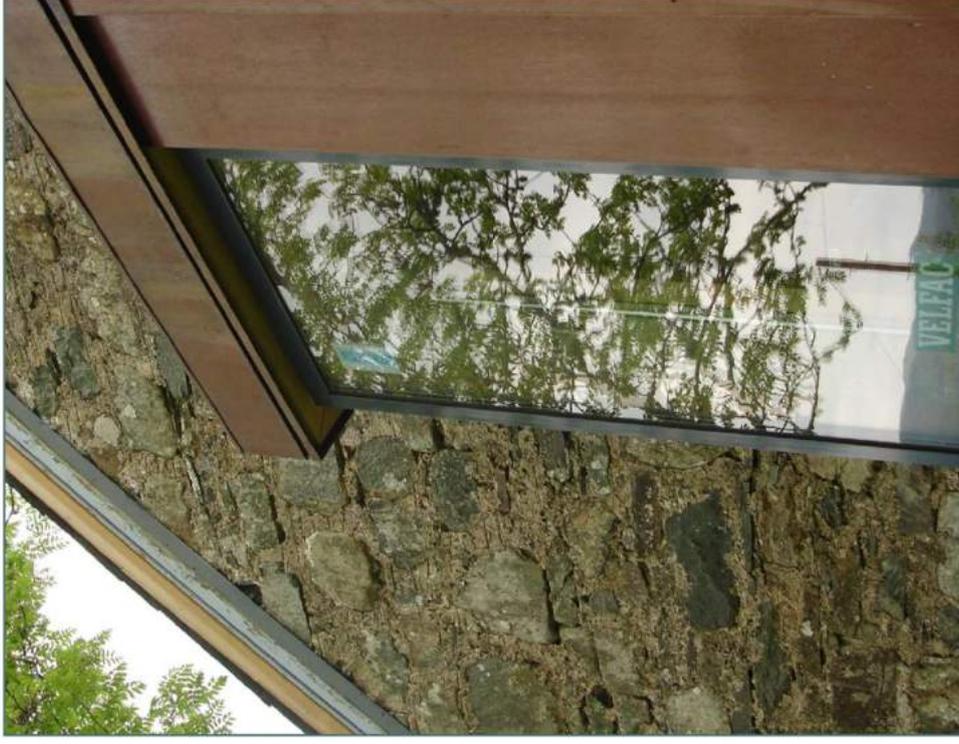
Contemporary details against traditional stonework  
Kirkwall Urban Design Development Framework p50
